THESIS

A CORRELATION BETWEEN THE HEAT
AFFECTED ZONE MICROSTRUCTURE AND THE
THERMAL HISTORY DURING WELDING OF HY-130 STEEL

September 1981

MASTER OF SCIENCE IN MECHANICAL ENGINEERING

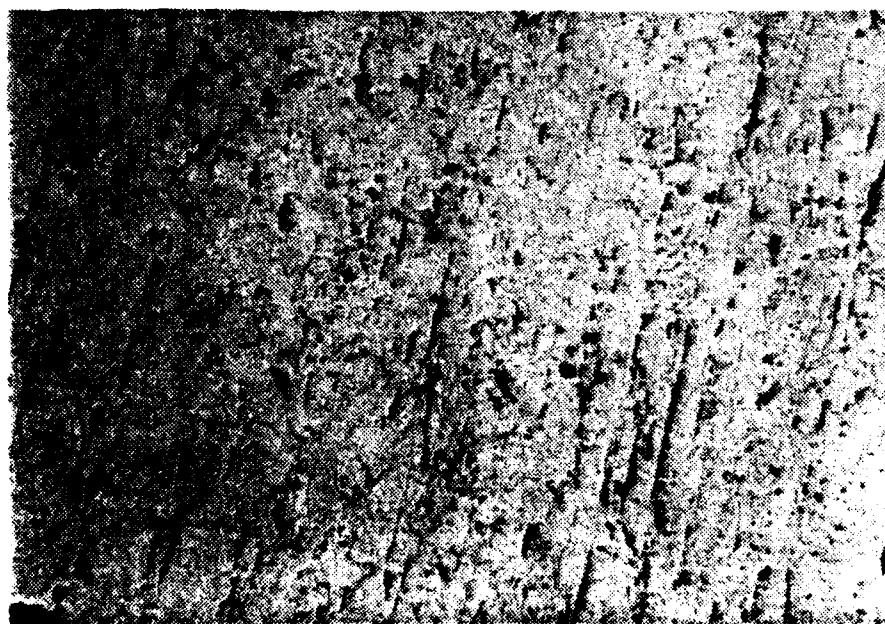
Figure 25. Location 3-4, 12.4 mm from the fusion line after welding.

These two thermocouples were located at distances of 12.2 millimeters (0.48 inch) and 12.4 millimeters (0.49 inch) respectively from the fusion line after welding. The microstructures shown in Figures 24 and 25 are very similar and are representative of the base metal structure that existed prior to welding, that of tempered martensite. Located outside the HAZ, the microstructure in these areas would indicate little effect from the welding process. The carbon extraction replicas made at these locations are also indicative of the tempered martensitic structure, showing evidence of larger coarse carbides intermixed with finer carbide particles. The microhardness measurements made at these thermocouple locations (Table VI) agree with the Rockwell hardness measurements made on the base metal (Tables 3, 4, 5) further indicating a negligible tempering effect here. The peak temperatures recorded for these locations (Appendix B) did not exceed 771°F(410°C). The time-temperature data indicated that the time spent at these temperatures was on the order of only a few seconds, so no appreciable tempering was expected.

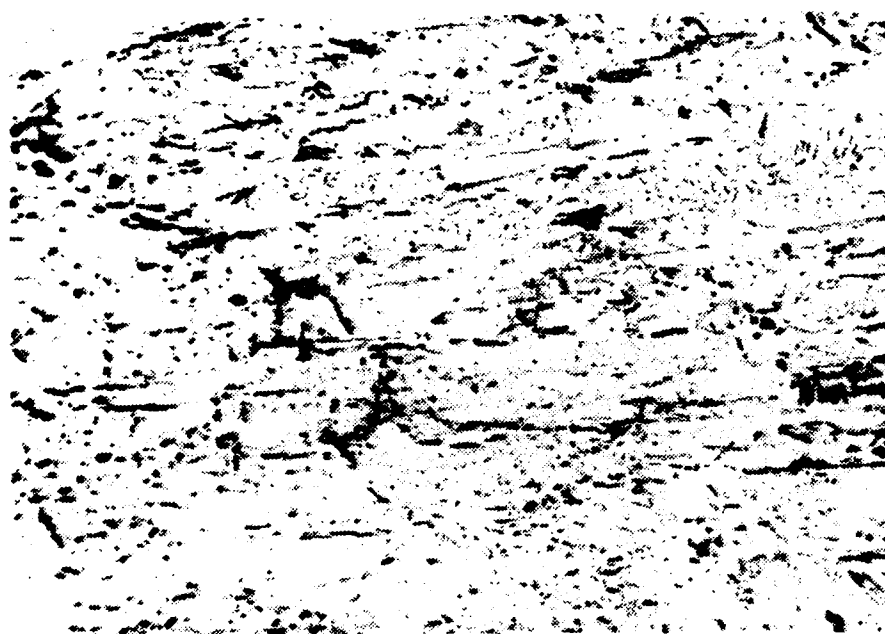
560X 5% Nital

1400X 5% Nital

8000X TEM Carbon Extraction Replica

Figure 27. Location 3-3, 8.4 mm from the fusion line after welding.

Thermocouples 1-3 and 3-3 were located at distances of 7.25 millimeters (0.29 inch) and 8.4 millimeters (0.33 inch) respectively from the fusion line after welding. The micrographs shown in Figures 26 and 27 again are similar to each other and are not very different from those at thermocouple

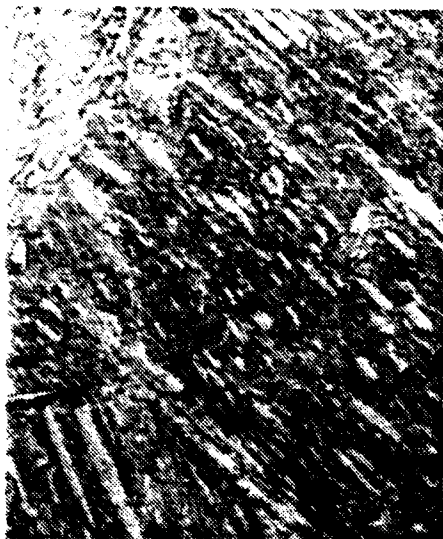
Figure 33. Location 4-1, 0.1 mm from the fusion line after welding.

Thermocouple 4-1 was mounted at the location of the last pass on the straight sequence welded side of the test plate, and was 0.4 millimeters (0.016 inch) from the fusion line after welding. The microstructure of the metal at this thermocouple location is shown in Figure 33, and consists entirely of untempered martensite. Since this was the location of the last pass, no evidence of tempering was expected and none was found. The dark spherical spot appearing in the 1400X micrograph is not an inclusion or void but is the remnant of a small depression created in the bottom of the thermocouple hole during drilling. The carbon extraction replica indicates the relief in the surface of the sample produced during etching, but shows no evidence of the presence of carbides. The peak temperature recorded by thermocouple 4-1 was 2242°F (1228°C), but it is felt that this value is erroneously low. Since this thermocouple was located closer to the fusion line than thermocouple 2-1, the peak temperature experienced here would be expected to be higher. A possible reason for the lower peak temperature is suggested by Figure 12. The bottom of the thermocouple hole may have retreated away from the fusion line area (buckled upwards into the thermocouple hole) with the approach of the weld bead, effectively moving the thermocouple away from the weld bead. A gap between the bottom of
